HYDROLOGICAL IMPACTS *of* **Traditional Community Irrigation Systems** *in* **NEW MEXICO**

BY ALEXANDER G. FERNALD,
STEVEN J. GULDAN,
AND CARLOS G. OCHOA

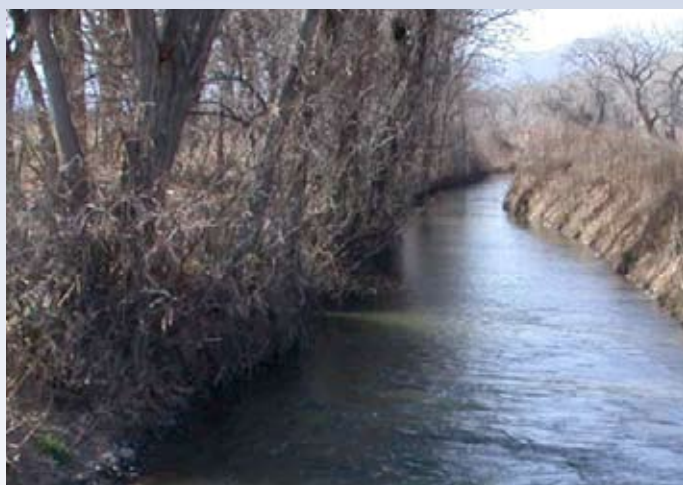
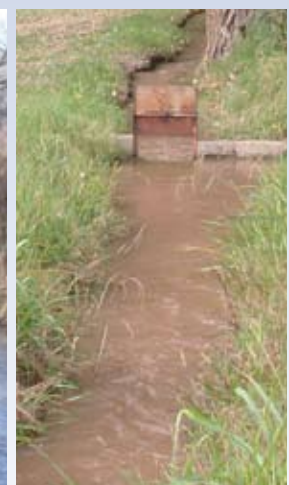
Figure 1. Two traditional community irrigation ditches.

This article compiles recent research results to describe new perspectives on hydrology of traditional community irrigation systems (Figure 1). In New Mexico, these irrigation systems have been in use for centuries, and at least 800 operating ditches exist in the state (OSE, 1991). For the most part, these are unlined earthen canals and convey water to fields that are flood irrigated. Studies have shown that these two aspects can result in significant amounts of water that seep

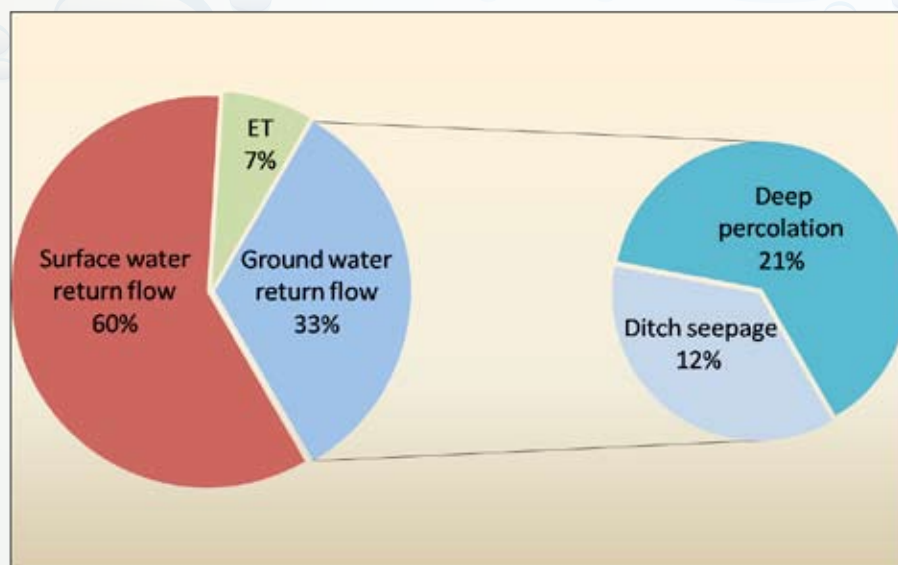
Figure 3. Three-year averaged water budget of the Alcalde community ditch.

Study results indicate that two key hydrologic functions are provided by these irrigation systems: contributing to shallow aquifer recharge; and providing groundwater return flow to the river. Measurements of shallow groundwater showed that during the 2007 irrigation season, the water table rose about two feet (0.6 meter). Also, a significant amount of this transient water table rise remained past the irrigation season, and because the river is gaining flow from the connected shallow aquifer, it was assumed that this additional water would become return flow to the river. Of river water diverted into the Alcalde community ditch, an average of 33% returned to the river as groundwater return

flow—12% originated as seepage from the ditch and 21% originated as seepage from the irrigated fields (Figure 3).

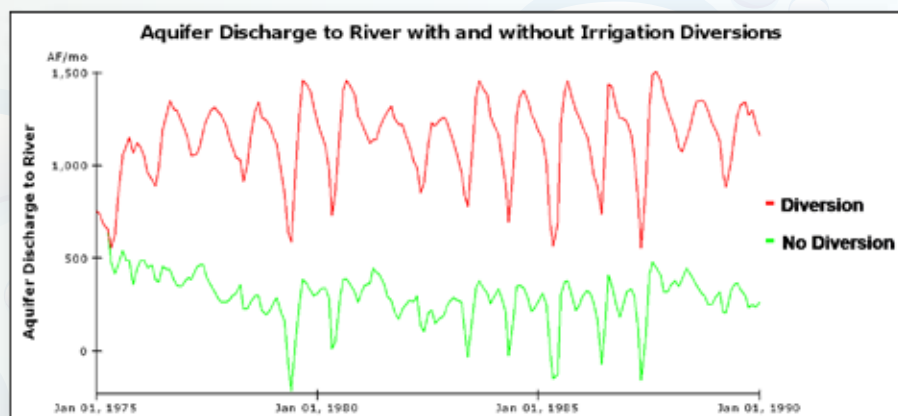
Figure 4. Effects of diversion on groundwater return flow to river. This figure is posted ahead of print (with permission from the American Society of Civil Engineers) (Fernald et al., 2010).

Figure 4 illustrates a simulation using a system dynamics model, under a scenario in which there are no diversions into community irrigation ditches (as would be the case, for example, if fields are no longer used for irrigated agriculture). In this hypothetical situation, there is less recharge of the aquifer, and so less groundwater return flow to the river. The current irrigation systems actually conserve water by keeping it underground, and the water that seeps from fields and ditches is stored temporarily then released into the river. We have termed this phenomenon “hydrograph retransmission” in which river runoff is stored and released later in the year (Fernald et al., 2010). The spring snowmelt hydrograph is delayed, and much like beaver dams of the past, this storage and release function provides water to downstream users during drier periods when it is most needed.
